## Product Change Notice (PCN)

PCN Number: **PCN-0450890R-01**

Product(s) Affected: *SJ1-351X-SMT Series (SJ1-3513-SMT-TR, SJ1-3514-SMT-TR, SJ1-3515-SMT-TR, SJ1-3515-SMT-TR-BE, SJ1-3515-SMT-TR-GR, SJ1-3515-SMT-TR-PI)*

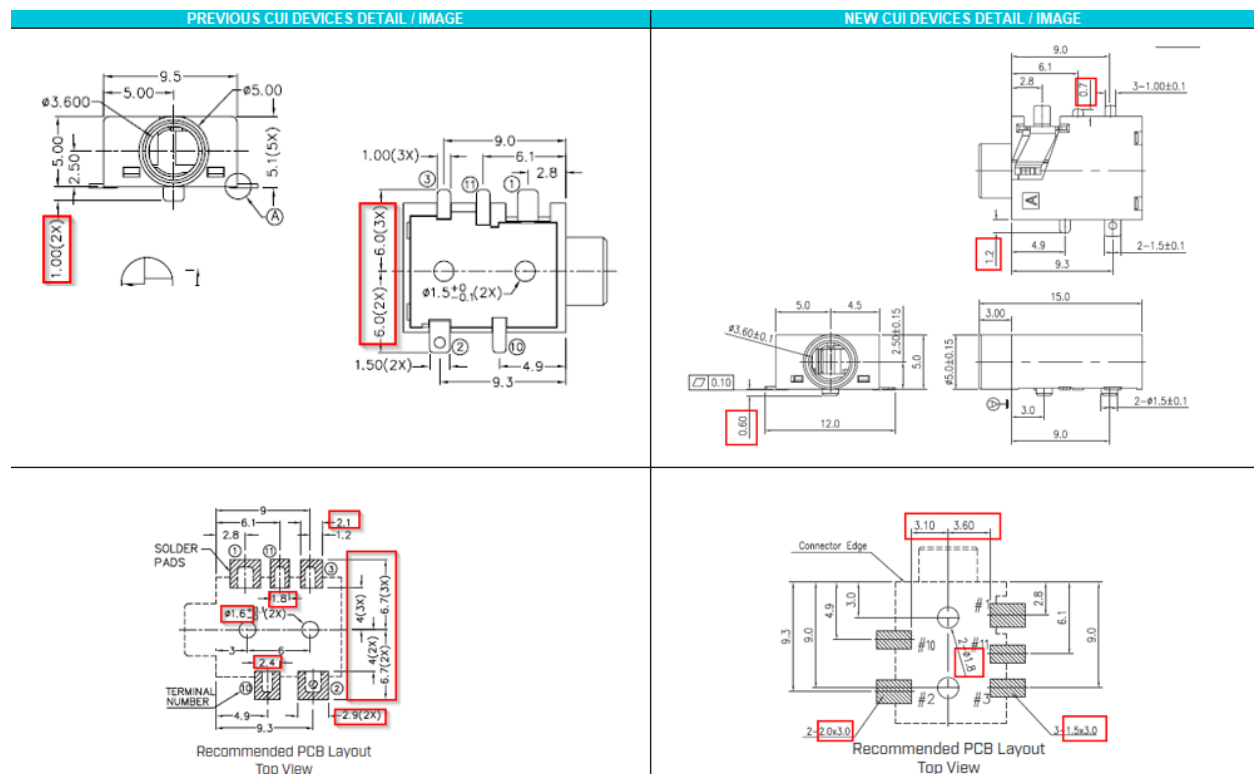
Description of Change: *Minor Housing and footprint differences. Material Change on the housing and terminals. See image Below*

PREVIOUS CUI DEVICES DETAIL / IMAGE			NEW CUI DEVICES DETAIL / IMAGE		
	MATERIAL	PLATING	DESCRIPTION	MATERIAL	PLATING/COLOR
terminal 1	copper alloy	gold flash	terminal 1	phosphor bronze t=0.30	gold flash over nickel
terminal 2	copper alloy	gold flash	terminal 2	phosphor bronze t=0.20	gold flash over nickel
terminal 3	copper alloy	gold flash	terminal 3	phosphor bronze t=0.20	gold flash over nickel
terminal 10	brass	gold flash	terminal 10	brass t=0.20	gold flash over nickel
terminal 11	brass	gold flash	terminal 11	brass t=0.20	gold flash over nickel
plastic	PA10T		cover	PAST [UL94V-0]	see color options
			housing	PAST [UL94V-0]	see color options

PIN				
1	sleeve	<del>sleeve</del>	sleeve	sleeve
2	tip	<del>tip</del>	tip	tip
3	ring	<del>ring</del>	ring	ring
10	NP	<del>NP</del>	tip switch	tip switch
11	NP	<del>ring switch</del>	NP	ring switch
